Case Study on the Wallasea (North) Managed Realignment Scheme (England)

White Paper

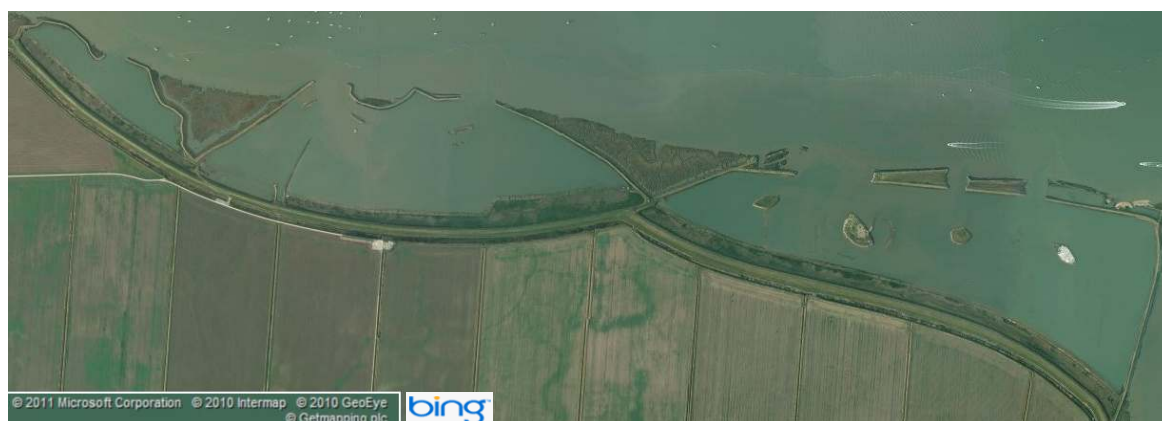
Plate 1. The managed realignment along the north bank of Wallasea Island (at high tide) – Bing Maps derived aerial view

For this scheme a new secondary wall was constructed (in 2005) about 400m back from existing sea defences. This new wall was an extension to one that had been constructed three years previously by the landowner. The majority of the site fronting these walls was at an elevation half way between Mean Low Water (MLW) and Mean High Water Neap (MHWN) and thus was suitable for mudflat development. To also create an area of saltmarsh, 550,000m³ of maintenance dredge arisings (from the Port of Harwich) were placed on the seaward side of the walls. This was deposited in a 45m-wide strip – it was contained by the new sea wall and a clay bund to its seaward side. The topography was raised to a level just below the Mean High Water Springs (MHWS) level using this sediment recharge approach. In addition, within the site, seven island features were created. A new borrow dyke (soke dyke) was excavated on the landward side of the new counterwall. No new internal creeks needed excavated to promote effective site filling and draining on each tide because the existing field drains and borrow dyke on the site fulfilled the function very effectively without manipulation. One new channel did have to be introduced though to connect one of the breaches directly back to a flood management sluice in the new sea wall.

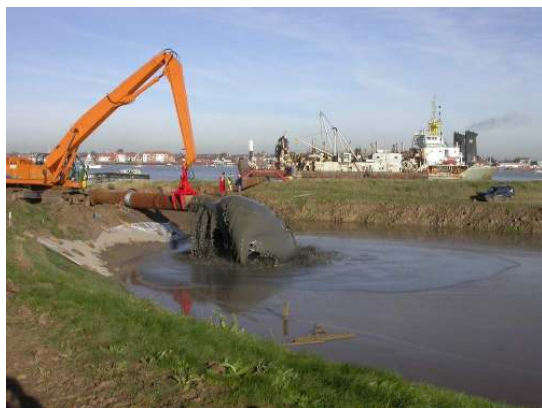
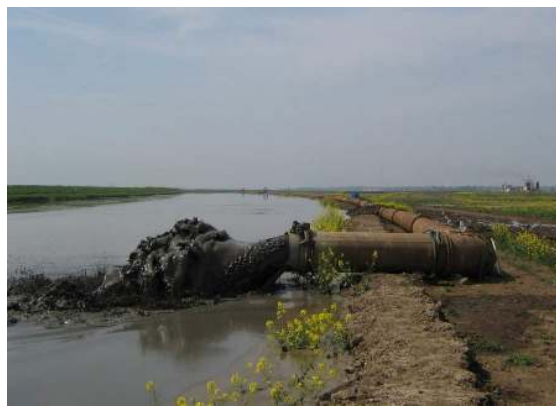
Plates 2 & 3. Dredge sediment recharging in November 2005 and May 2006

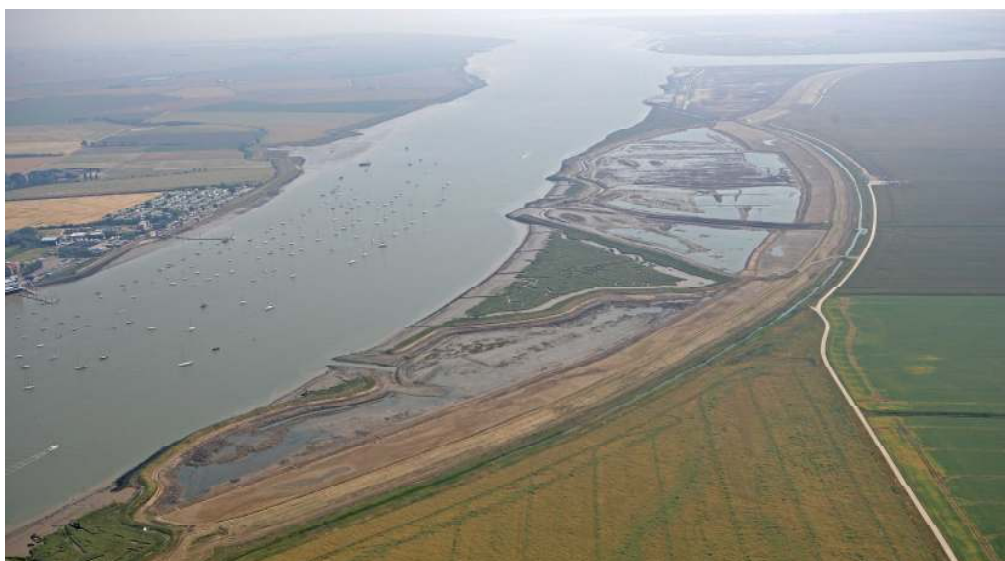
Plate 5. The site on the final day of breaching (view east)

In early Summer 2006, six breaches were made through the existing seawall to flood this 115ha site. The total width of the breaches is 590m, with one breach being 210m wide and the others being either 60m or 100m. The final breach arrangements were selected based on a range of factors; they were positioned to provide the requisite flows through the site and also to minimise the losses of saltmarsh habitat in front of the existing seawall. They were also located to integrate well with the existing foreshore. For instance, Breaches 1, 2 and 3 in (the most easterly) Area A were located on prominent headlands to ensure that the narrow intertidal areas either side of the breaches continued along a relatively unaltered parallel alignment with the seawall. This ensured that there was no significant creek formation across the fronting intertidal after realignment. Analysis was undertaken to check whether stable regime channels would form at the centre of the unaltered parallel alignment with the seawall. This ensured that there was no significant creek formation across the intertidal after realignment. Analysis was undertaken to check whether stable regime channels would form at the centre of the breaches. The proposed breaches are much wider than the minimum width suggested by the modelling and, as such, the flows were dissipated sufficiently to ensure that there is no significant scouring of the sediment. The site as a whole is separated into three discrete areas with no exchange of water flow between them so that it acts like three individual but contiguous realignment sites.

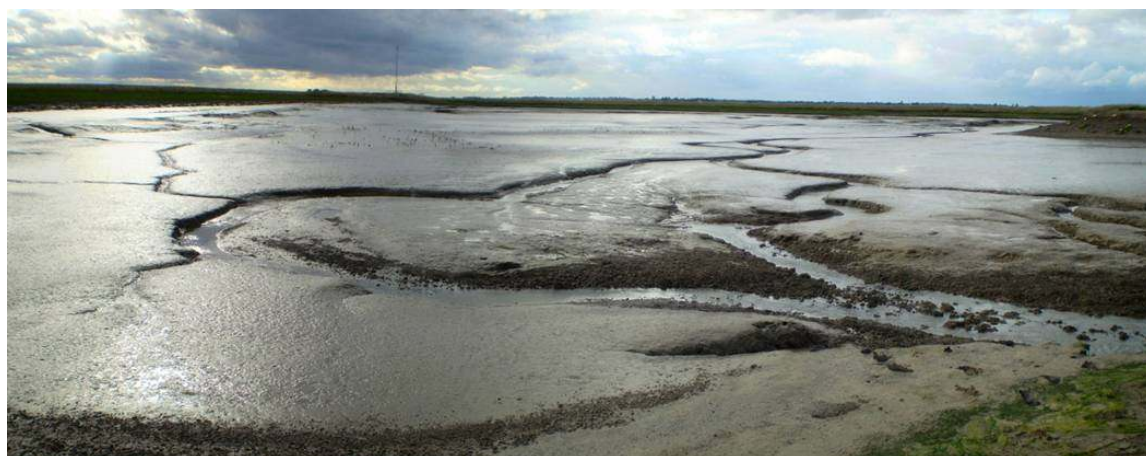
Plate 6. View of mudflat within site, showing drainage creeks formed as sediment has accreted

The breaches and channels through them are very stable which confirms the effectiveness of the approaches that were taken to design them.

Within the site, sediment accretion has occurred relatively consistently and evenly due to the slow flows and stable internal creek/channel configurations. In the first year after breaching (2006 to 2007), accretion was around 10cm (of which about 50% is considered internally relocated materials and 50% externally imported sediments). In each subsequent year, the annual accretion is considered to be predominantly related to imported sediments and amounted to 3 to 5cm on average (specifically 5cm in both 2008 and 2009, and 3cm in 2010).

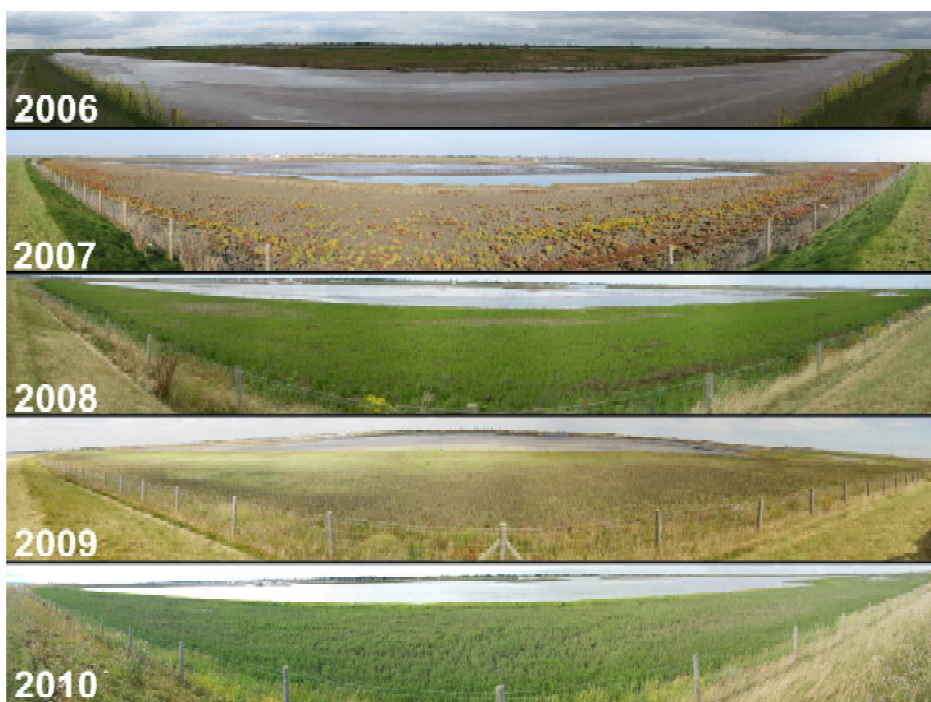
Plate 7. Fixed-point photographs showing the rate of saltmarsh development on the recharge sediment

Saltmarsh coverage of elevated areas of the sites (approx 25ha in extent) has occurred relatively rapidly. On average plant coverage (i.e the amount of marsh plant compared to bare mud at any given location) has rapidly increased from less than 1% in 2007 to 6% in 2008, 60% in 2009 and finally at or around 100% in 2010.
